Vincenzo Riso

Álvaro Siza's Lordelo do Ouro Cooperative Building

Álvaro Siza's Lordelo do Ouro Cooperative Building: Preliminary Studies towards the Conservation of a Masterpiece in Need of Recognition

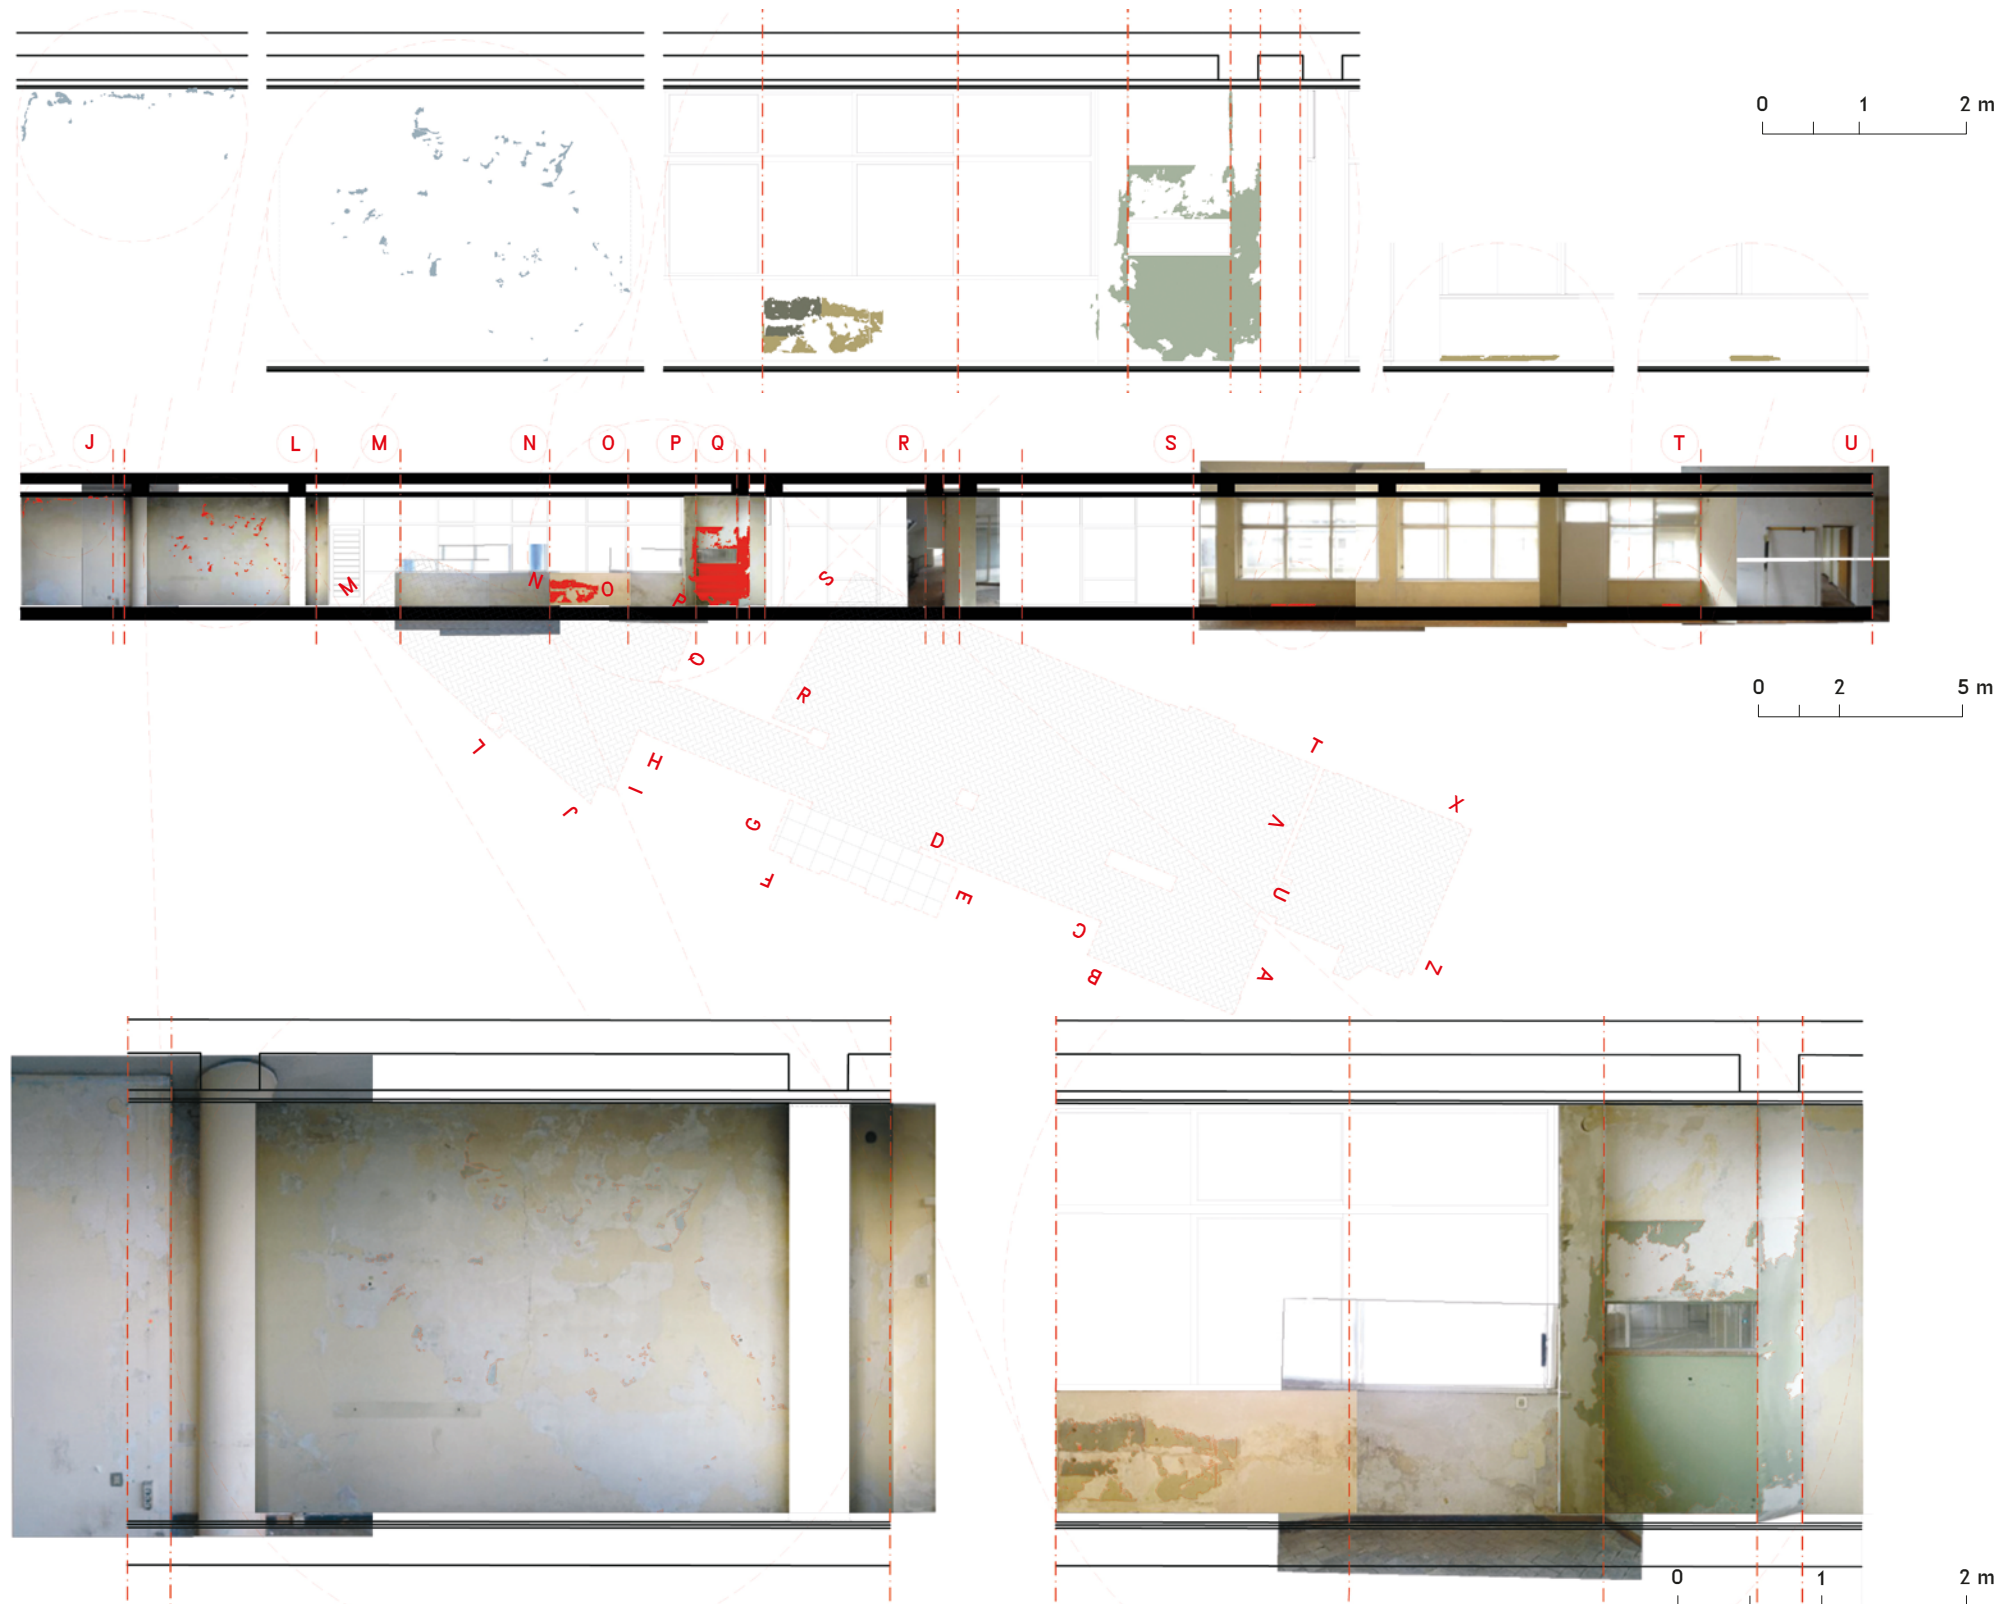
Fig. A.10

Examples of construction anomalies in the palimpsest-layer of the Penthouse of the Soares & Irmão building (architects Arménio Losa and Cassiano Barbosa, Porto, 1950–54), abstract from C. Maia Op. Cit., pp. 462–463.
